Drainage investment pays off

Bringing land back into productive cropping is the aim of a land drainage scheme recently completed on a south Wales farming estate. Peter Hill reports.

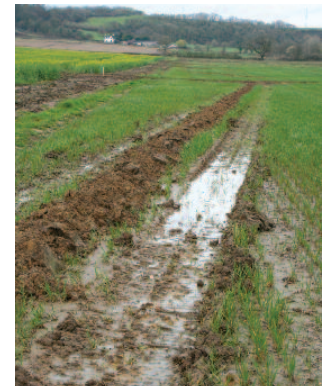
Soil pushed back over the trench will be levelled with a rotary tiller once settled.

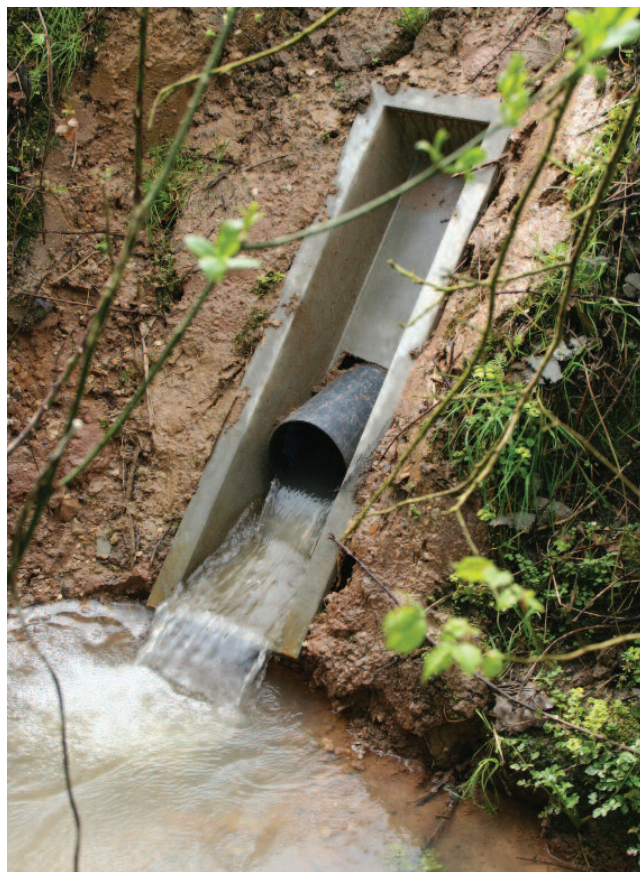
Water has been gushing from the mains since an hour or so after they were laid.

Four weeks after being laid in early March, water is flowing out of the 80mm pipe at a fair rate of knots – and has been from within an hour of being put in the ground as part of a herringbone pattern scheme installed by contractor William Morfoot.

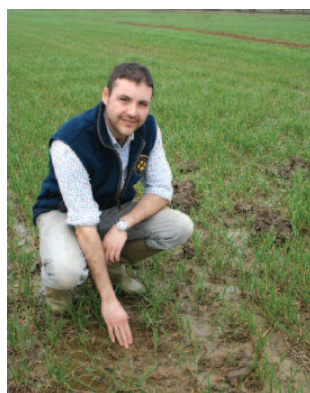
Damien Burnell points out the barely visible trace of the tracked gravel cart.

In the meantime, the old hedge line and tramlines provided a useful access route for the self-propelled gravel cart, which despite a fully laden all-up weight of 33 tonnes left barely visible track marks where it had to cross virgin ground.

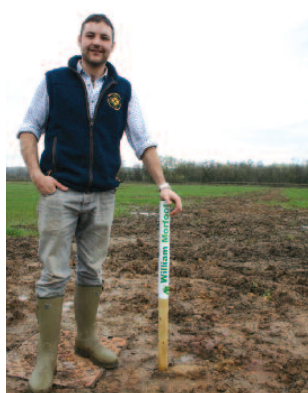
Marker post highlights the location of an inspection chamber for jetting access.

To start putting that right, a motley hedge running from one end of the site to the other was cleared with half an eye to combining the land on either side into one field. As it is, conservation scheme rules require that it be re-instated, which is why pre-cast concrete inspection chambers set into the two mains to facilitate flushing if needed in future coincide with its location.

combination of marker posts and GPS co-ordinates now entered into the estate's Gatekeeper farm records as a permanent record of the location of the new outfalls, which continue to run as a huge volume of water shifts out of the soil.

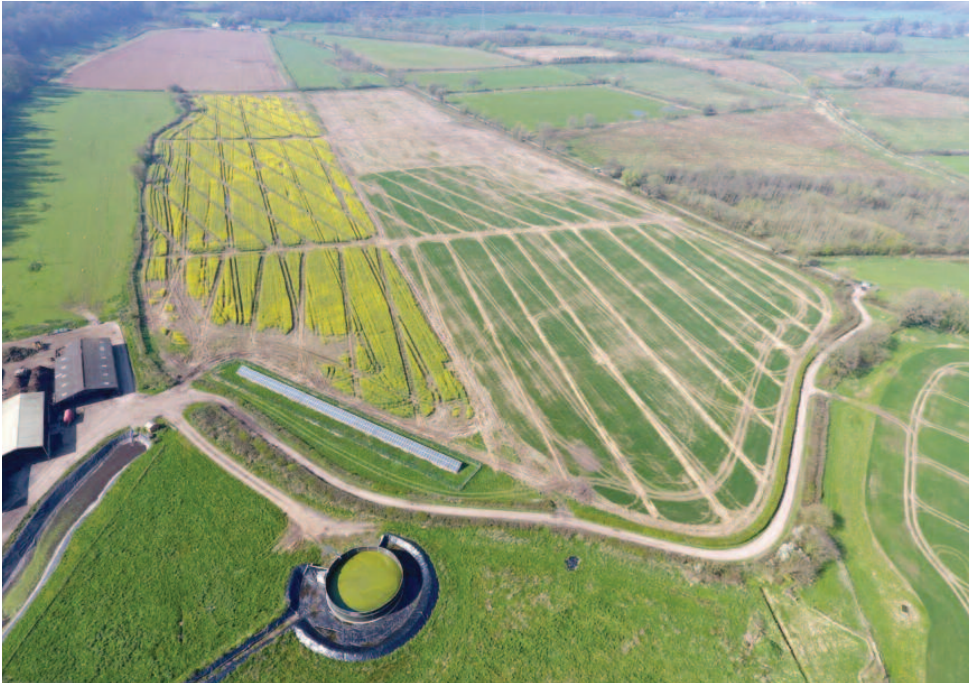
An aerial view of the first 20ha (50 acre) block to be drained; fields at the far end and bottom right are also due to be drained during the next three years.

William Morfoot was engaged to further investigate the issues and undertake a detailed survey early this year. The firm's quad bike GPS survey provided a digital topographical map while studying old paper farm maps revealed how water flows were managed around former field boundaries – the first block of 20ha (50 acres), for example, was once eight individual paddocks.

The natural contours of the land and overall shape of the fields called for a herringbone

layout, using 80mm and 100mm perforated plastic pipe for the laterals at 20m spacing feeding into a pair of 160mm main drains running down the slope to an existing ditch.

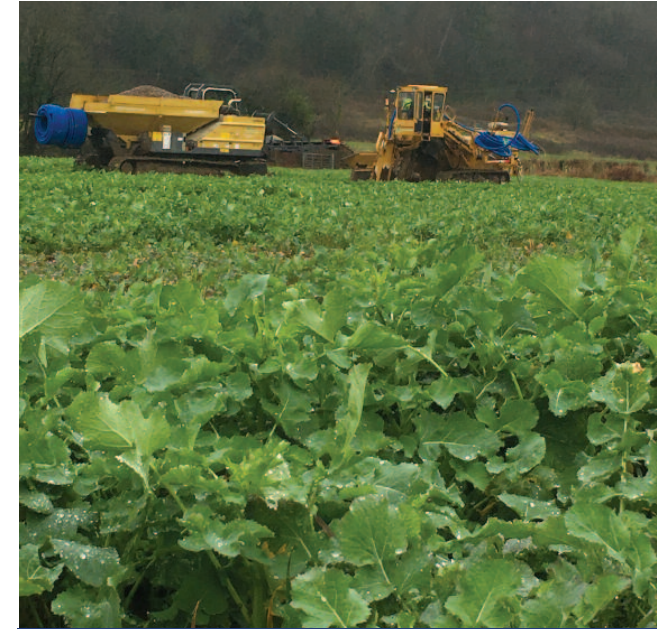
Contractor William Morfoot's trencher and backfill wagon work in tandem.

Gravel backfill was added to an average depth of 450mm as it is considered a key factor in assisting rapid infiltration of surface water into the piped network.

With everything agreed, no time was lost in getting the scheme underway, with Morfoot's Mastenbroek tracked trencher guided by GPS steering and gradient control working its way through oilseed rape in the western side of the site and poorly established winter wheat on the eastern portion.
